## Open Letter to All Coal Miners, Coal Mine Operators and Contractors

### Take Time to Refocus on Safety

Enclosed are the MSHA Fatalgrams from the first 14 fatalities this year. Please read them and consider why these accidents happened and how you would have responded in similar circumstances.

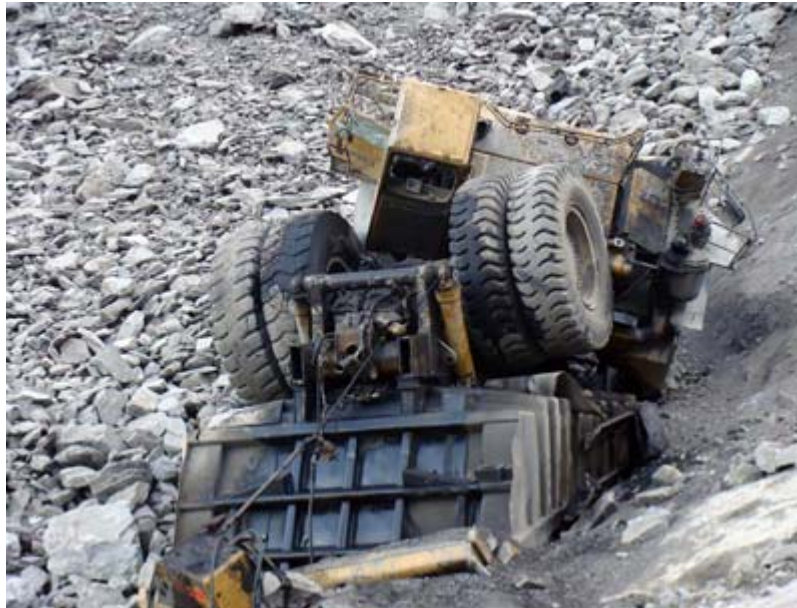
**Fatality #1 - January 8, 2008**  
**Powered Haulage - Surface - Kentucky**  
**Cumberland River Coal Company - Blue Ridge Surface Mine**

**COAL MINE FATALITY** - On Tuesday January 8, 2008, a 29-year old truck driver with three years experience was fatally injured while attempting to dump spoil. The truck over-traveled the edge of the dump and rolled down the spoil slope approximately 140 feet.

- Provide and maintain adequate berms and other barriers of mid-axle height for dump sites.
- Routinely monitor work habits and examine work areas to ensure that safe work procedures are followed.
- Ensure equipment operators receive proper task training.
- Ensure work areas and dump sites are properly illuminated at night.
- Conduct pre-operational checks of equipment before placing into operation.
- Use seat belts when operating equipment.

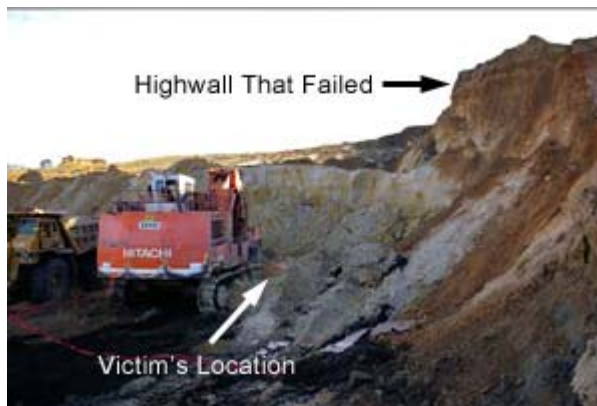
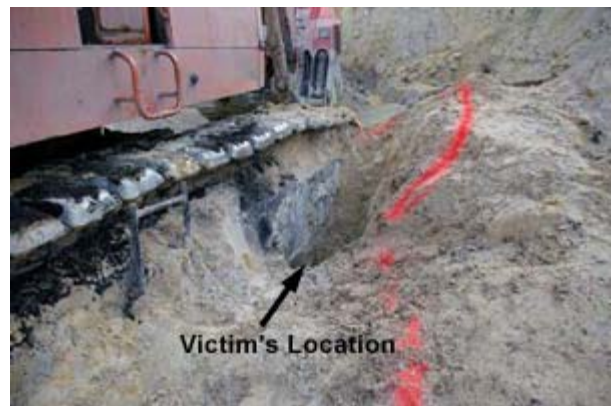
**Fatality #2 - January 12, 2008**

**COAL MINE FATALITY** - On Saturday, January 12, 2008, a fall of highwall accident resulted in fatal injuries to a shovel operator with 22 years of mining experience. The shovel was located parallel to and approximately 40 feet away from the toe of the highwall which was approximately 45 feet high. During a normal work break, the shovel operator climbed off the shovel. While the shovel operator was positioned between the toe of the highwall and the shovel, the highwall collapsed and pushed the victim against the track of the shovel. After returning to the pit and finding the shovel operator missing, a haul truck driver radioed for assistance. The shovel operator was found mostly covered in the sandy loam type material from the highwall. The victim was recovered but CPR was unsuccessful.

- Never work or position yourself near or under dangerous highwalls or banks.
- Promptly correct or post unsafe ground conditions.
- When unsafe ground conditions are found during on-shift examinations and are being corrected, notify all persons working in the area of the hazard and post the affected area until the unsafe condition is corrected.
- Do not work or position yourself between equipment and the highwall such that equipment may hinder escape from falls or slides.

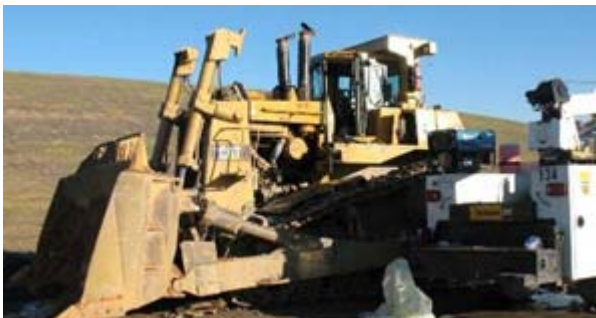
Bulldozer and rear of service truck

**COAL MINE FATALITY** - On Friday, February 1, 2008, a 34-year old field mechanic (contractor) with 13 years of experience was fatally injured while troubleshooting a diesel engine on a bulldozer. A valve cover, rocker assembly, and fuel injector had been removed from the cylinder head. The victim was observing the valve lifters while the engine was turned-over to place the lifters in a better position for retrieval. The victim was struck and fatally injured by material expelled from the cylinder head as the engine was cranked.

- Always wear eye protection when working near moving parts.
- Follow equipment manufacturer's protocols and procedures when working on equipment.
- Move to a safe location when there is a danger of high-pressure releases of fluids or objects.
- Always use the proper tools, parts, and equipment to safely perform the work.

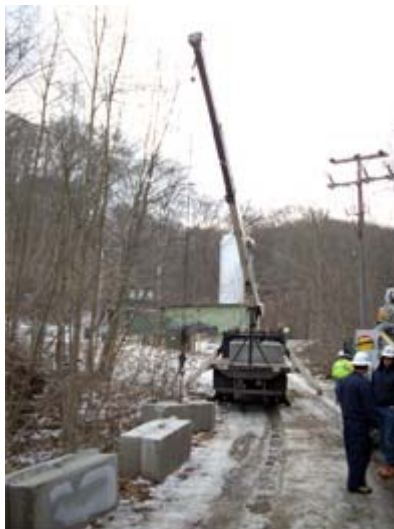
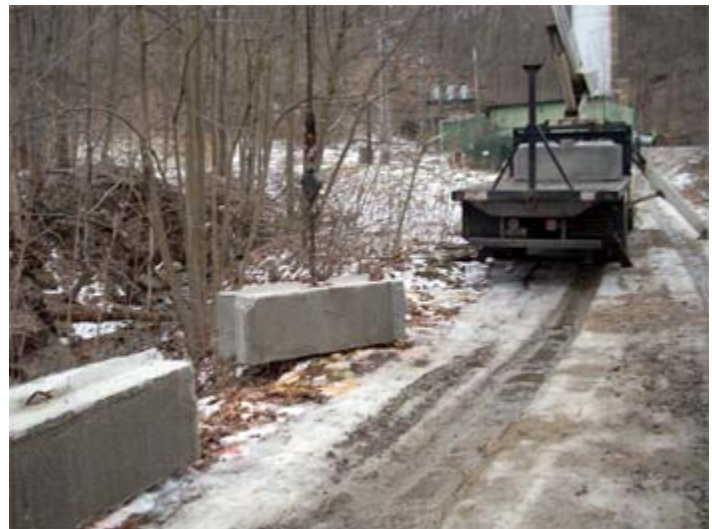
**Fatality #4 - February 18, 2008**

**COAL MINE FATALITY** - On Monday, February 18, 2008, a 51-year old outside service technician (contractor) with one year of experience was fatally injured while placing concrete barriers along a mine access road. A rubber-tired boom truck was being used to move the concrete barriers into place. The victim was electrocuted while standing on the ground, touching a suspended concrete barrier, when the boom came in contact with an energized 14,500 volt overhead power wire. The operator of the boom truck was treated and released.

- Ensure that booms or masts of equipment are not operated within 10 feet of any energized overhead powerline.
- Identify hazards associated with tasks prior to work assignments.
- Ensure that one person on the ground is designated to give signals to the crane operator and watch placement and proximity of the mast.
- Use non-conducting tag lines to steady loads when operating cranes where overhead power lines are present.

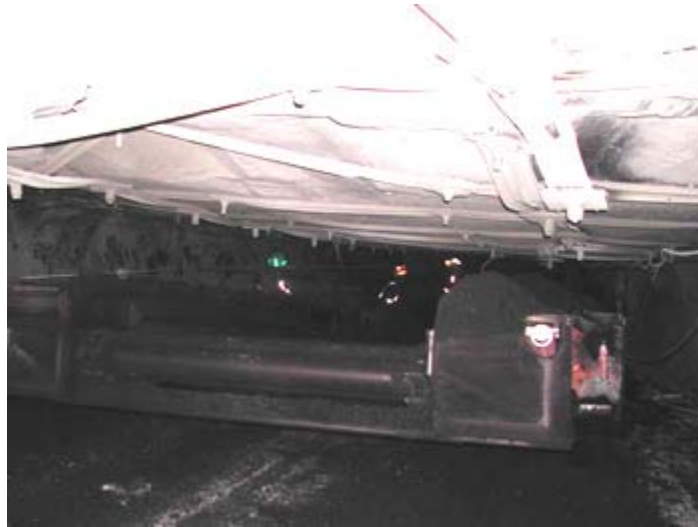
**Fatality #5 - February 25, 2008**  
**Powered Haulage - Underground - Pennsylvania**  
**AMFIRE Mining Company LLC – Nolo**

**COAL MINE FATALITY** - On Monday, February 25, 2008, a 50-year old surveyor (contractor) with 8 years of total experience was fatally injured while surveying in an active underground continuous mining machine section. The victim was struck by a loaded shuttle car as it traveled through a run-through check curtain.

- Never position yourself in an area or location where equipment operators cannot readily see you.
- Before operating mobile equipment, always ensure that other miners are not in the area of your intended travel.
- Sound warnings when the operator's visibility is obstructed, such as when making tight turns, reversing direction, or approaching curtains.
- Wear reflective clothing to ensure high visibility when necessary to walk or work in the area of moving equipment.
- Perform surveying at times when the section is not in production.

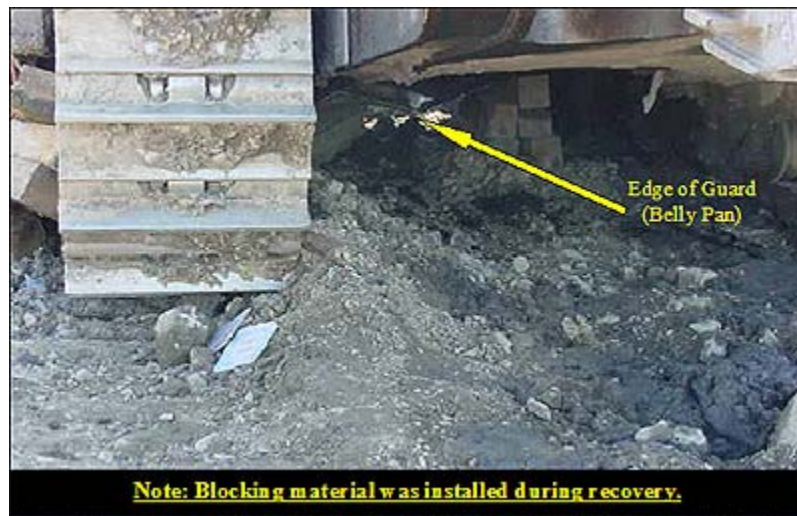
**Fatality #6 - March 12, 2008**  
**Machinery - Mill/Prep Plant - West Virginia**  
**Appalachian Fuels, LLC - Alloy Prep Plant #1**

**COAL MINE FATALITY** - On Wednesday, March 12, 2008, a 47-year old mechanic/contractor with 21 years of experience was fatally injured while attempting to remove a front guard assembly (belly pan) from a bulldozer. The victim was positioned beneath the bulldozer, removing mounting bolts from the bulldozer guard. The guard was supported by a chain attached to a remote-operated truck-mounted crane. As the bolts were removed, the chain support slipped and the guard fell.

- Always follow the equipment manufacturer's recommended maintenance procedures when conducting repairs to machinery.
- Install blocking materials before mounting bolts are removed from machinery components which may fall during disassembly.
- Conduct training for miners assigned to new work tasks to ensure they are aware of the health and safety aspects and safe work procedures related to the assigned tasks.

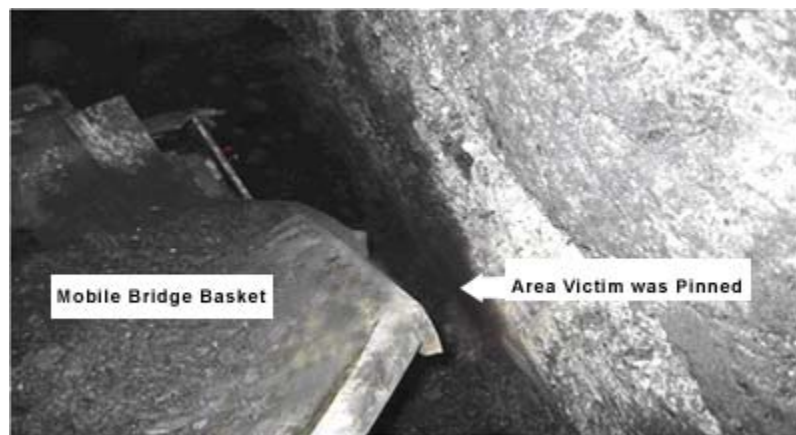
**Fatality #7 - April 18, 2008**  
**Machinery - Underground - Pennsylvania**  
**Rosebud Mining Company - Little Toby Mine**

**COAL MINE FATALITY** - On Friday, April 18, 2008, a 43-year old continuous miner operator with 3½ years experience was fatally injured while operating a continuous miner with an attached mobile bridge conveyor system. As the victim was positioning the continuous miner in a crosscut turning right, the inby mobile bridge operator felt an unusual bouncing of the bridge and failed to get a radio response from the miner operator. The bridge operator shut the system down using the emergency stop switch and crawled toward the face and discovered the victim pinned between the basket of the bridge and the left rib.

- Frequently review, retrain, and discuss avoiding the **"RED ZONE"** areas when operating or working near a remote controlled continuous mining machine.
- Follow established safe work practices and provide periodic training along with checks to ensure that the safe work practices have been properly implemented.
- Pursue new technology such as proximity detection to protect personnel and eliminate accidents of this type.
- Minimize the number of miners working or traveling near operating systems and maintain an effective means of communications between miners and system operators.

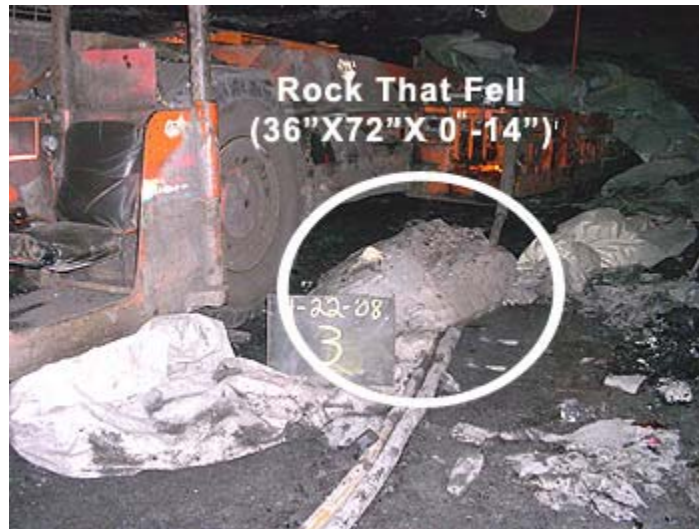
**Fatality #8 - April 22, 2008**  
**Fall of Roof or Back - Underground - Virginia**  
**Osaka Mining Corporation - Mine No. 1**

**COAL MINE FATALITY** - On Tuesday, April 22, 2008, a 61-year old roof bolting machine operator with 30 years of mining experience was fatally injured while observing a continuous mining machine producing coal at the working face. A rock approximately 36" x 72" x (0"-14") fell from the roof, striking the victim and the continuous mining machine operator. The victim was fatally injured by the roof fall and the continuous mining machine operator received nonfatal injuries.

- Conduct a thorough visual examination of the roof, face, and ribs immediately before any work is performed and thereafter as conditions warrant.
- Be alert to any change of roof conditions.
- Identify and remove loose roof material from a safe position.
- Mine personnel not essential to the specific activity should remain outside the work zone.

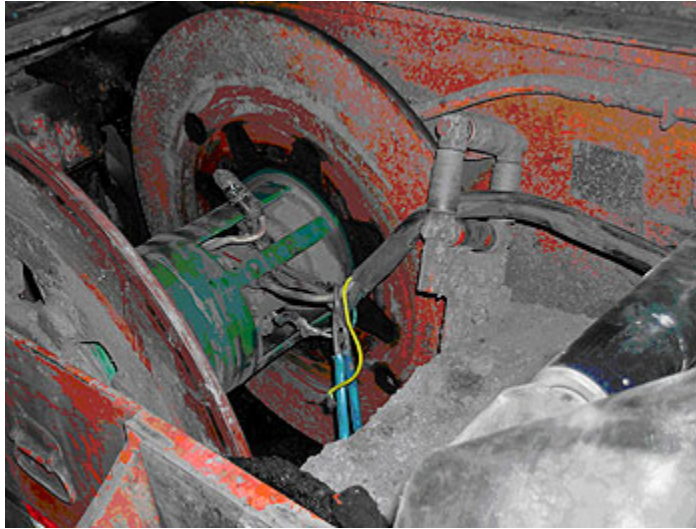
**Fatality #9 – May 16, 2008**  
**Electrical - Underground - West Virginia**  
**Aracoma Coal Company, Inc. - Aracoma Alma Mine #1**

**COAL MINE FATALITY** - On Friday, May 16, 2008, a 24 year old electrician with 4 years of mining experience was fatally injured when he cut into an energized shuttle car trailing cable. The victim was attempting to make an electrical repair on the shuttle car when he used a cable cutter tool to cut into an energized lead.

- Personally lock-out and tag-out electrical circuits before you perform electrical work on a cable or component.
- Do not rely on anyone else to deenergize or disconnect a circuit.
- Maintain multiple locks and tags available to lock circuits.
- Maintain electrical meters and testing instruments in good condition to verify that the circuit is deenergized before beginning work.
- Communicate your intentions to work on an electrical circuit to ensure the circuit is, and remains, protected.

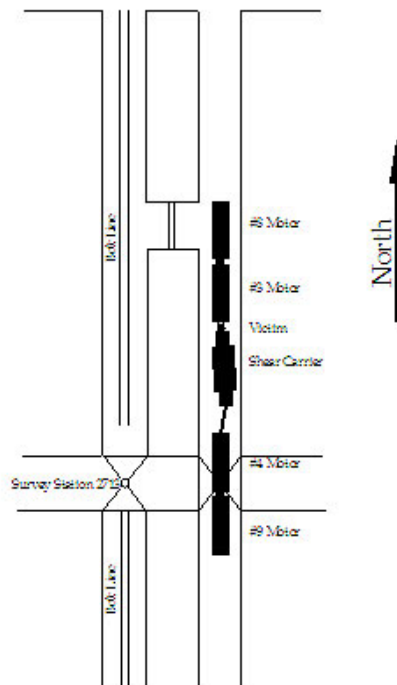
**Fatality #10 – May 22, 2008**

**COAL MINE FATALITY** - On Thursday, May 22, 2008, a 64-year old underground locomotive (motor) operator with 25 years experience was fatally injured when he was pinned between his motor and a longwall shearer being transported on a rail type carrier. The victim, three other operators, and a foreman, were transporting the longwall shearer body to a longwall setup section when the carrier derailed as it was moving upgrade. The victim dismounted the #3 motor to assist in rerailing the carrier. He was between the motor and the carrier when the motor(s) slid or rolled back, crushing him between the shearer body and locomotive.

- Never place yourself between rail cars/equipment unless positive stop blocks are in place.
- Always set parking brakes when getting off mobile track equipment.
- Pull, do not push rail cars.
- Always be aware of your location in relation to mobile equipment.

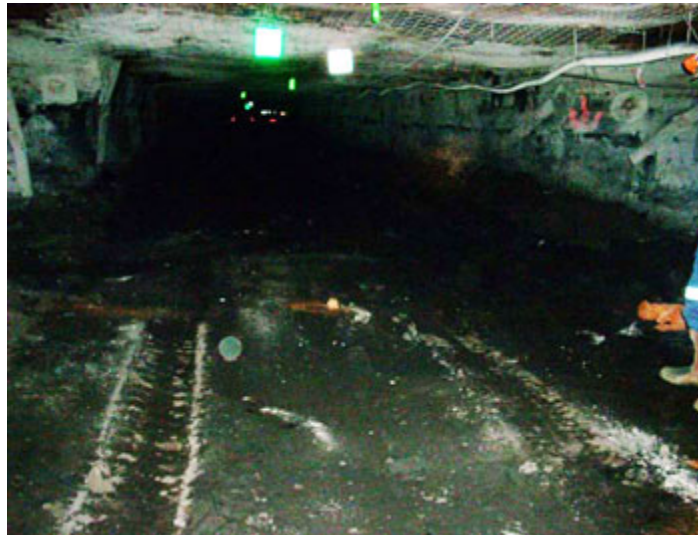
**Fatality #11 – May 30, 2008**  
**Powered Haulage - Underground - West Virginia**  
**Wolf Run Mining Company - Sentinel Mine**

**COAL MINE FATALITY** - On Friday, May 30, 2008, a general inside laborer with four weeks experience was fatally injured when he was struck by a battery powered scoop. The victim was assisting two other miners repair a haul road. The scoop operator had just changed out the scoop batteries and picked up a load of gravel. The victim was traveling on foot and was being followed by the scoop and a diesel road grader. While in route, the scoop operator inadvertently struck the victim causing fatal injuries.

- Remain a safe distance from moving equipment until it has passed.
- Walk behind moving mobile equipment when traveling in the same entry.
- When operating mobile equipment, ensure that other workers are in a safe area before moving the equipment.
- When necessary to walk or work in the area of moving mobile equipment, wear reflective clothing to ensure a high visibility.
- Always assume the mobile equipment operator has not seen you unless eye contact is confirmed.

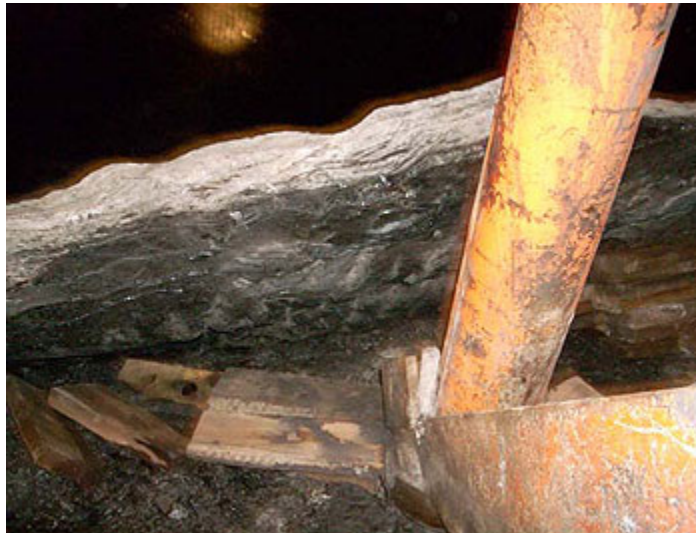
**Fatality #12 – June 3, 2008**  
**Fall of Roof or Back - Underground - Indiana**  
**Gibson County Coal, LLC - Gibson Mine**

**COAL MINE FATALITY** - On Tuesday June 3, 2008, a 25 - year old roof bolting machine operator with 2 years of mining experience was fatally injured by a fall of roof. A rock measuring approximately 5' in length x 11' in width and 0" to 10" in thickness fell from beyond permanent support and cantilevered outby striking the bolter operator and pinning him between the foot cylinder of the pressurized ATRS.

- Never travel inby supported areas.
- Always conduct a through visual examination of the roof, face and ribs immediately before work is performed and thereafter as conditions dictate.
- Always stay alert for changing conditions in your work area.
- Scale any loose or hazardous roof material using proper equipment and scale from a safe location.
- Know and follow the approved roof control plan.

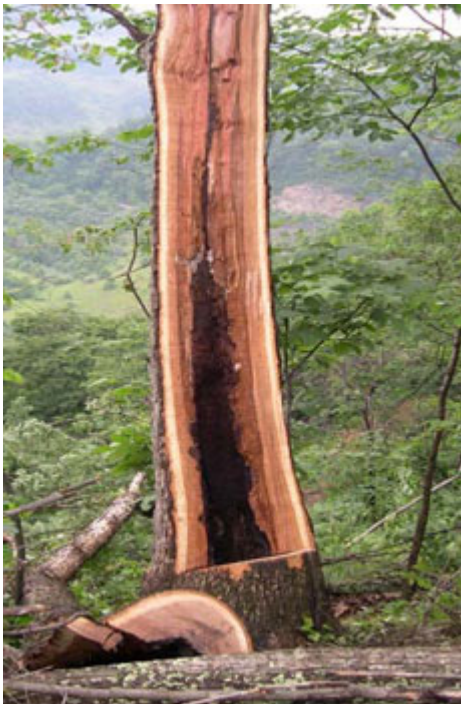
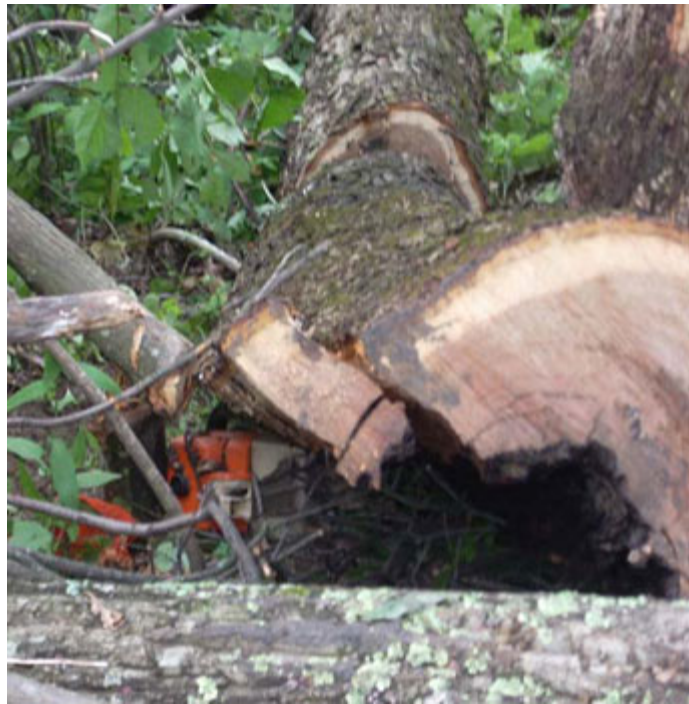
**Fatality #13 – June 3, 2008**  
**Machinery - Open Pit - Kentucky**  
**Premier Elkhorn Coal Company - Job #49**

**COAL MINE FATALITY** - On Tuesday, June 3, 2008, a 33-year old tree cutter (contractor) with 10 years experience was fatally injured while cutting trees in advance of a surface mining operation. The victim had made a notch cut on a 24" diameter tree and was in the process of completing the back cut when the tree slabbed from the stump approximately 16 feet high then fell on the victim. The tree contained a hollow center which promoted the slabbing.

- Examine the area around the tree to be cut for hazards from previously felled trees, vines, underbrush, etc.
- Ensure that a clear escape route is present at a 45 degree angle away from the tree.
- Always make an open face (notch) cut in the direction the tree should fall. This cut should be of adequate depth (25% of tree diameter) and the two cut angles should total 90 degrees.
- Use bore cutting whenever possible, leaving a hinge equaling 10% of the tree diameter to guide the fall of the tree and hold it to the stump during the majority of the tree's fall.
- The final cut should be level.
- Chainsaw bar should be of sufficient length to reach through the diameter of the tree.

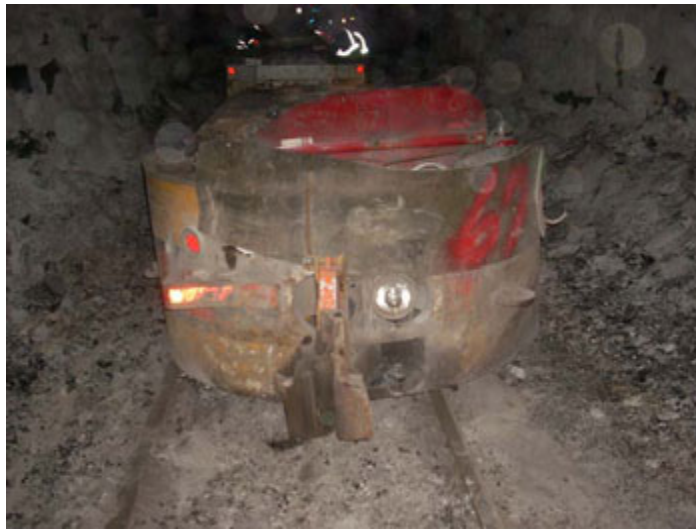
**Fatality #14 – June 5, 2008**  
**Powered Haulage - Underground - West Virginia**  
**Consolidation Coal Company - Robinson Run No 95**

**COAL MINE FATALITY** - On Thursday, June 5, 2008, a lead motorman (locomotive operator) was fatally injured while transporting supplies on two mine rail cars. The tail motorman, traveling behind the trip approximately 300 to 400 feet, discovered the victim between the clearance side of the track and the mine rib along the haulage. The victim's locomotive continued traveling in by and derailed approximately 1,400 feet from the location of the victim. The track haulage was down grade in the area where the accident occurred.

- Apply sand to mine rails to assure locomotive operators can safely stop.
- Assure locomotives are coupled to each end of the trip to maintain control of the load.
- Assure the weight of the load being transported does not exceed the braking capacity of the haulage equipment.
- Always conduct an adequate pre-operational examination of haulage equipment prior to use.
